The Level III building survey at Midcroft, Burgh-by-Sands confirmed that one east-west aligned clay dabbin wall existed within an extant building subject to redevelopment. The condition of the wall appeared to be excellent although 19<sup>th</sup> and 20<sup>th</sup> Century remediation had impacted upon the wall.

*Archaeological Building Survey (Level III) for Midcroft, Burgh-by-Sands, Carlisle*

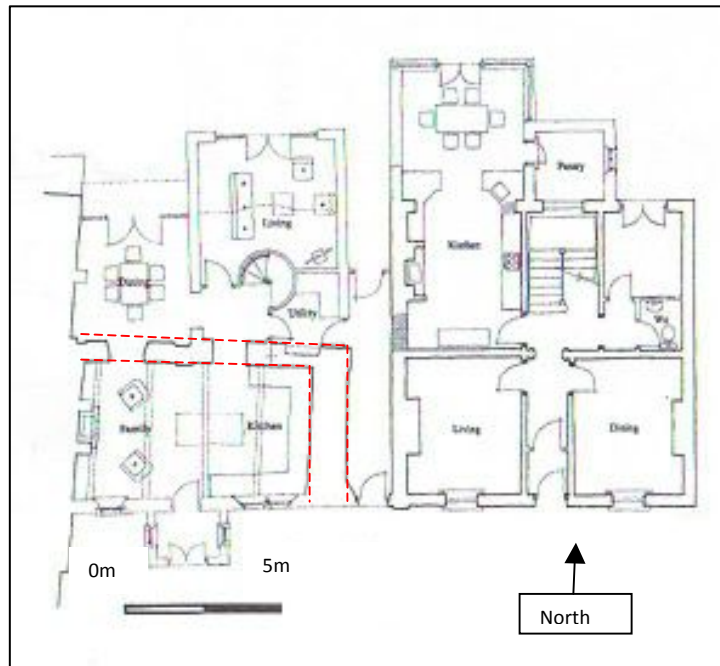
Figure 4. Ground plan of proposed development adjacent to Midcroft House

To be retained within the development are two thick walls, believed to be of clay dabbin construction outlined in red on figure 4.

On completion of the development the building elevations will conform to figure 3 and the ground plan will adhere to figure 4.

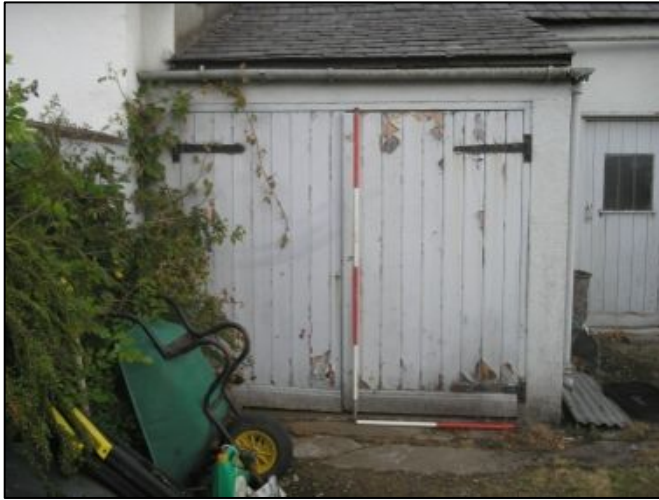
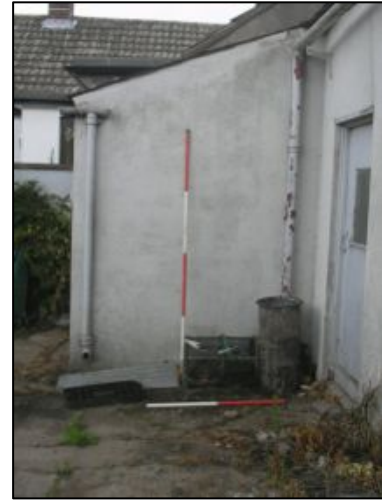
Figures 7 and 8. Elevation showing garage doors and protruding annex

Room 1, a garage, comprises a rectangular ground plan 2.30m x 2.26m with a height of 2.18m rising to 2.82m.

The garage forms a small forward protruding modern annex built from red brick with a thickness of 0.23m to the east and a double thickness to the west where it forms a party wall. The walls were finished in pebble dash with a double door constructed in timber tongue and groove providing the main exit.

The roof was constructed in slate with iron guttering the floor was concrete.

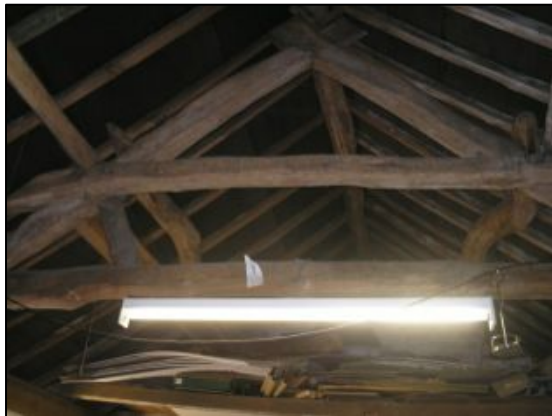
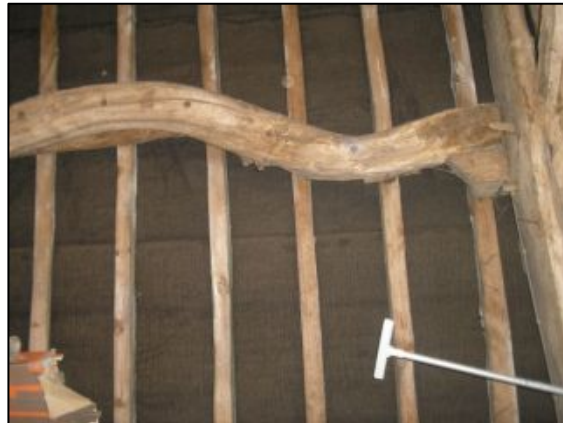
Figures 9 and 10. Roof trusses within Room 2 showing re-used timbers and purlins

The roof consisted of two triangular timber roof trusses supported on brick columns. There was no indication of soot or blackening of the timbers or purlins suggesting despite the trusses being pinned by wooden dowels these timbers had been salvaged from another source.

The rafters within the roof were modern, the slates pinned to a modern felt membrane.

The roof stood to a height of 4.56m.

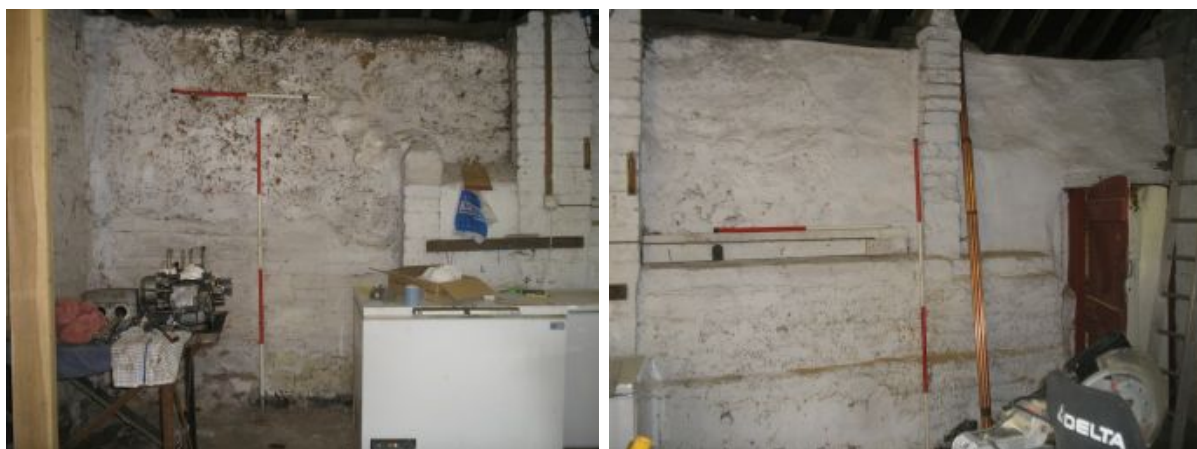
Figures 13 and 14. Western and eastern sections of clay dabbin wall, northern wall

The wall has been considerably altered in order to support the original clay dabbins wall (4). This wall occupied the upper part of the elevation measuring 7.00m in length and 1.35m in height and a thickness of 0.77m.

At the western end of the elevation, the pale yellow clay dabbin was roughly finished and pock-marked. Straw was visible but a plaster finish or lime wash was negligible. Two iron hooks had been driven into the dabbin wall at a height of approximately 2.10m above the floor

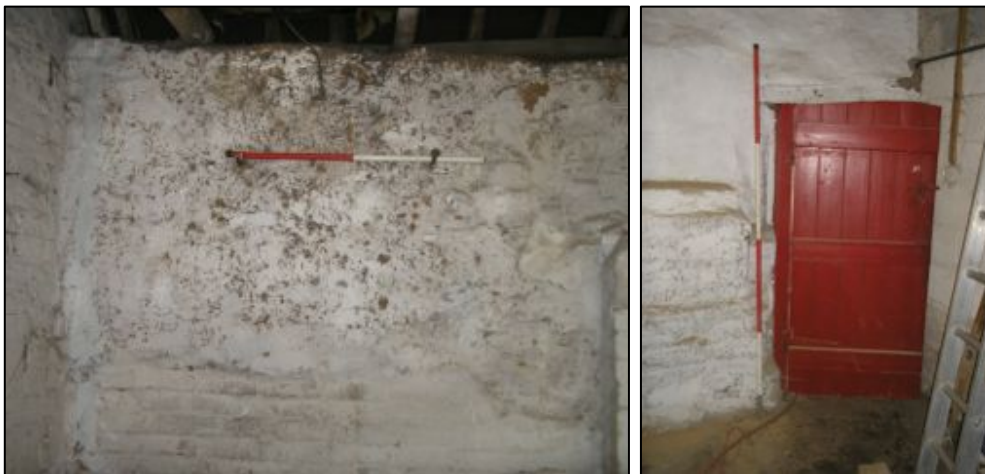
Figures 15 and 16. Detail of clay dabbin wall and modern door, north wall

Stone or cobble was partially visible at the centre of the elevation the dabbin wall being covered in a thin white cement render whilst the eastern end had been finished with a smooth cement render. As no cross-section was available, the wall's construction could not be ascertained

A timber door constructed using tongue and groove planks within a timber door jamb appeared to be a recent amendment although the overlying timber lintel may possess some antiquity.

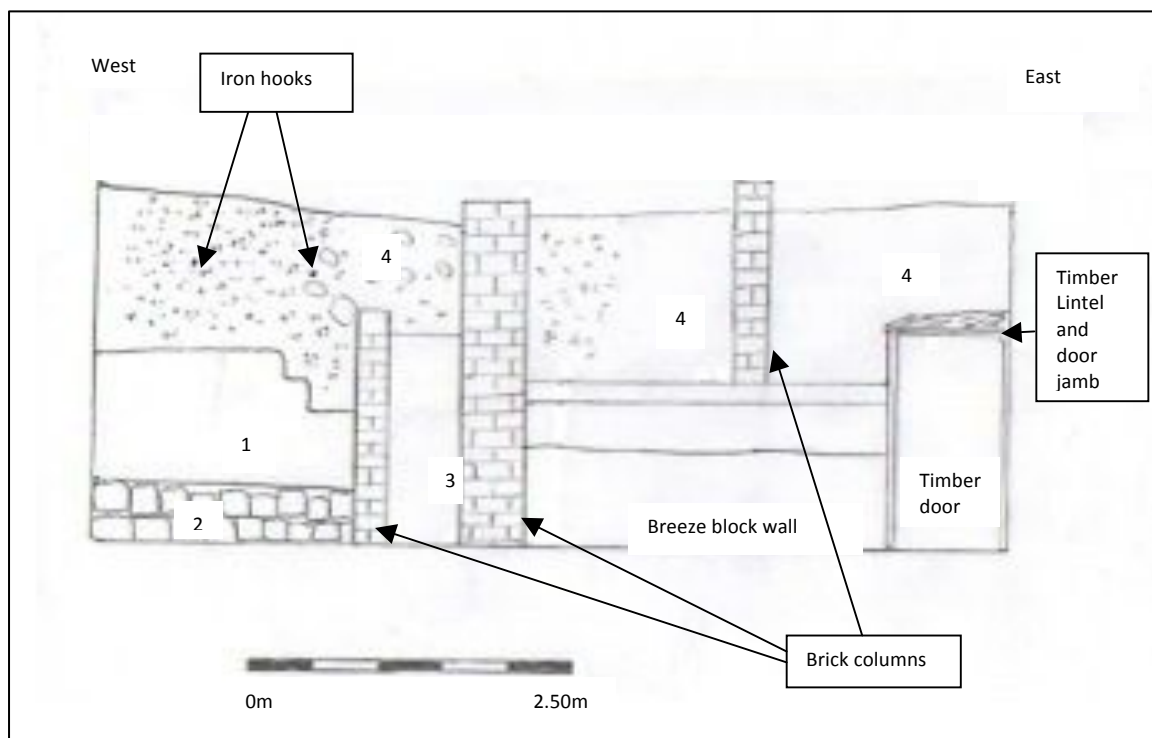
Figure 17. Elevation of north wall

Possibly, the dabbin wall was supported upon a stone plinth or dwarf wall comprising roughly hewn squared sandstone blocks painted white (2) towards the west but this relationship was lost or obscured by the insertion of a red brick wall (1) that was covered in white emulsion paint.

Three brick columns were constructed of which the two tallest supported later roof trusses. This activity may have coincided with the insertion of a low modern breeze-block wall painted white that extended from the central column to the door jamb. The gap (3) between the western and central brick columns was filled with cement

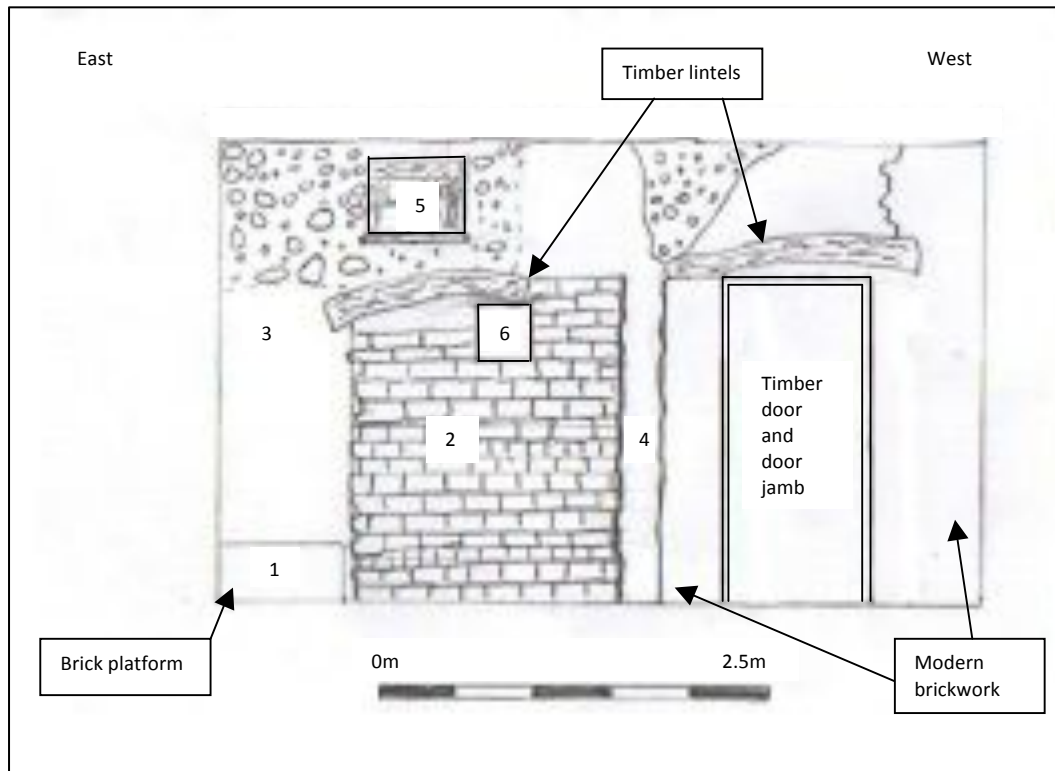
Figure 18. Elevation of southern wall

The elevation of the southern wall was also heavily altered but displayed no surviving evidence for a clay dabbin wall.

The earliest fabric within the elevation of the south wall was a cobble wall (3) standing to a height of 2.89m and approximately 4.10m in length. It comprised of large rounded stone cobbles circa 0.15m-0.20m in size and occasional dressed sandstone blocks coated in limewash with occasional spreads of extant plaster.

A possible lost northern return or partition was indicated by a short stub of stone wall (4) that measured 0.23m in thickness.

Within the elevation were a number of architectural features that had subsequently been filled with brickwork when they became redundant.

A window (5) measured 0.65m x 0.58m and possessed a plain wooden surround (no chamfering of the frame or embellishment) possessing possible wooden shutters. The window was unglazed, filled with brick and not visible from the outside.

A timber lintel (1.16m x 0.18m) indicated a lost entrance measuring 1.40m in width and 1.90m in height that had subsequently been filled with red bricks (2) painted white probably initiated during

the nineteenth century. A small glazed window (6) measuring 0.33m x 0.30m bearing a small wooden lintel was left within the additional brickwork.

A small brick plinth or platform (1) measuring 0.77m x 0.26m and 0.38m in height was constructed butting wall (3).

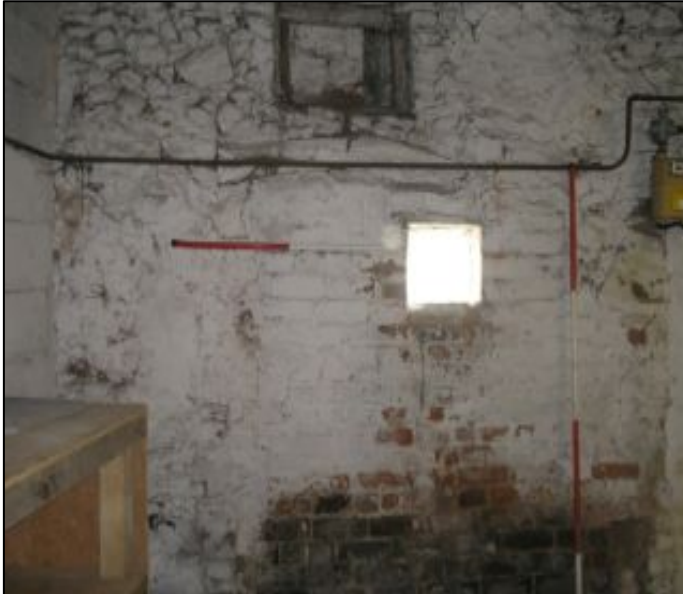
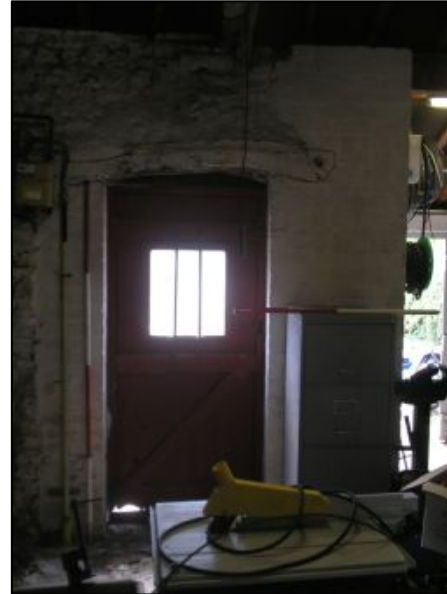
Figures 19 and 20. Eastern and western sections of southern wall elevation

The western side of the elevation had been considerably rebuilt probably when the garage was added. The wall was refurbished in red brick as a doorway with a timber tongue and groove planked door measuring 2.07m x 0.94m the central element beneath a timber lintel measuring 1.60m x 0.18m that may bear some antiquity.

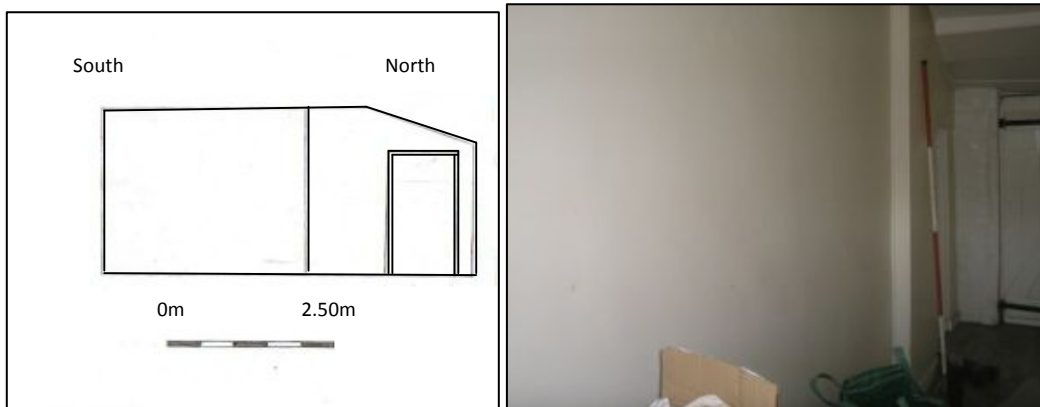
Figures 24 and 25. Elevation of hidden clay dabbin wall behind western wall of hallway

The western wall was boxed in with plywood and painted white, the clay dabbin wall not being available for examination. Within this elevation was a stone door jamb measuring 1.02m in width and 1.88m in height containing a wooden tongue and groove door.

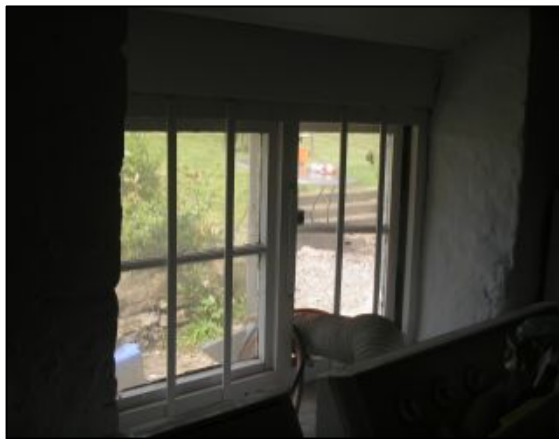
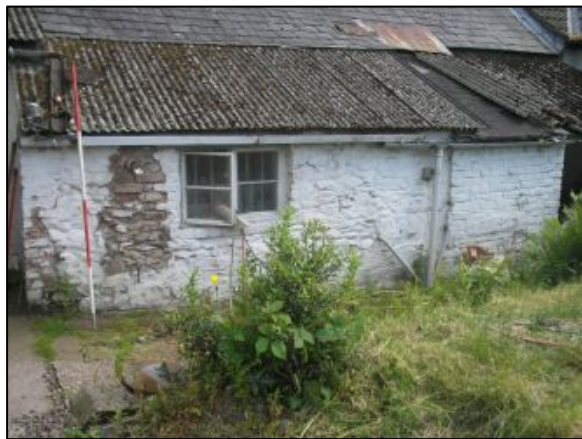
Figures 31 and 32. Window within utility room and elevation of lean-to building (Rooms 4 and 5)

A single stone step led into the utility room that contained a sink. The room possessed a modern double window measuring 1.05m x 0.82m facing north.

Rooms 4 and 5 formed an outbuilding that abutted Room 2 (workshop) to the north measuring 5.75m in length and 2.25m in width. The outbuilding possessed an asbestos roof with a height varying between 1.50m and 1.80m rising to 2.45m where it adjoined the main building.

The outbuilding was constructed from a mixture of stone and red brickwork with red brick quoins obscured by white limewash and paint. The facade had been repointed and was of relatively modern date.

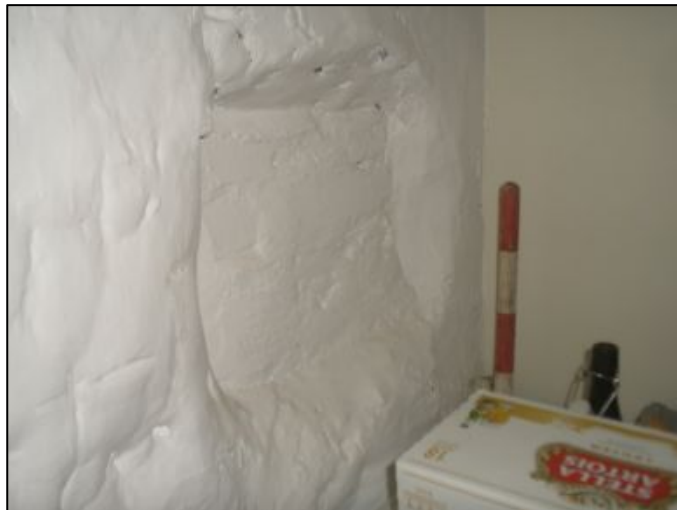
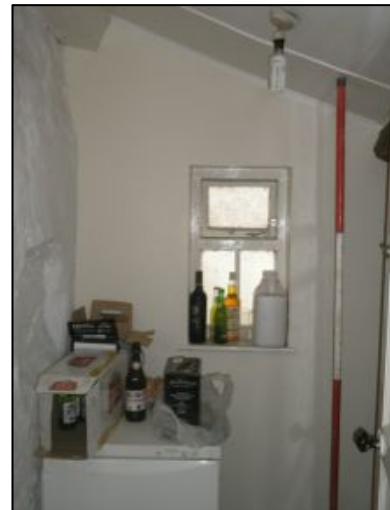
Figures 34 and 35. Recess within clay dabbin wall and view of Room 5

Room 5 measured 2.22m x 1.60m and stood to a height of between 1.76m and 2.14m containing a toilet, the western wall measuring 0.22m in thickness. The room was accessed through a doorway (no door present) measuring 0.67m in width and 1.95m in height

On the southern side of Room 5, a clay dabbin wall was heavily limewashed and exhibited a small square recess measuring 0.43m x 0.35m that had been filled in with brick.

On the northern side of Room 5, the stone wall was painted white.
