The construction works did not impact upon the wreck of the City of Ottawa, the mitigation strategy successfully implemented.

Gerry Martin has been commissioned by Mr Dylan Jones representing Martin Wright Associates Ltd (the client) to prepare a Specification of Works for a Programme of Archaeological Watching Brief Action relating to the reconstruction of the coastal defences at West Rhyl (figure 1).

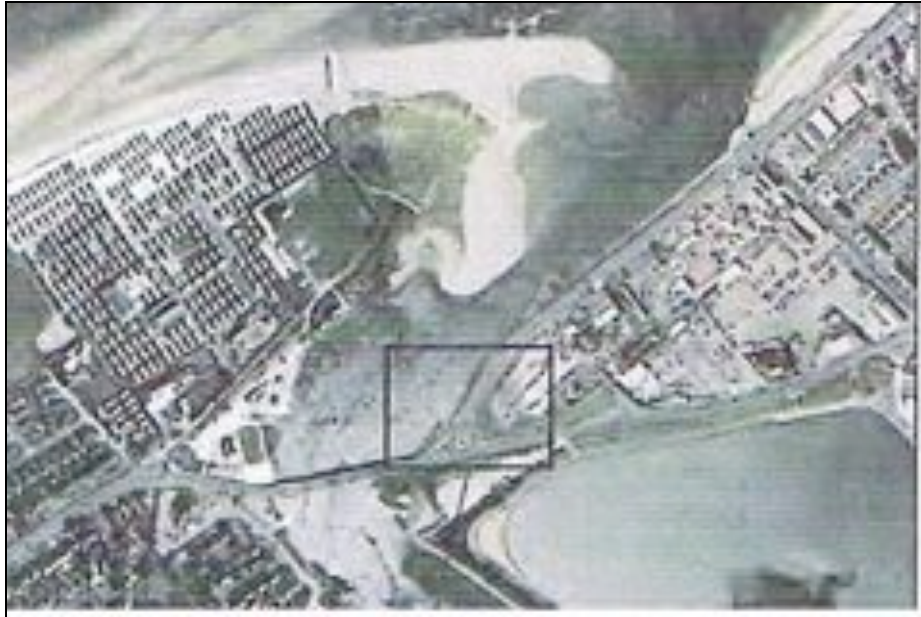
Figure 2. Aerial photograph of the study area

The study area comprises low-lying tidal mud flats resting above a shingle beach within Foryd harbour. Long shore drift has enclosed the harbour to the north, a small inlet providing access to open water (figure 2). The tidal range can be considerable, up to 4.00m at high tide.

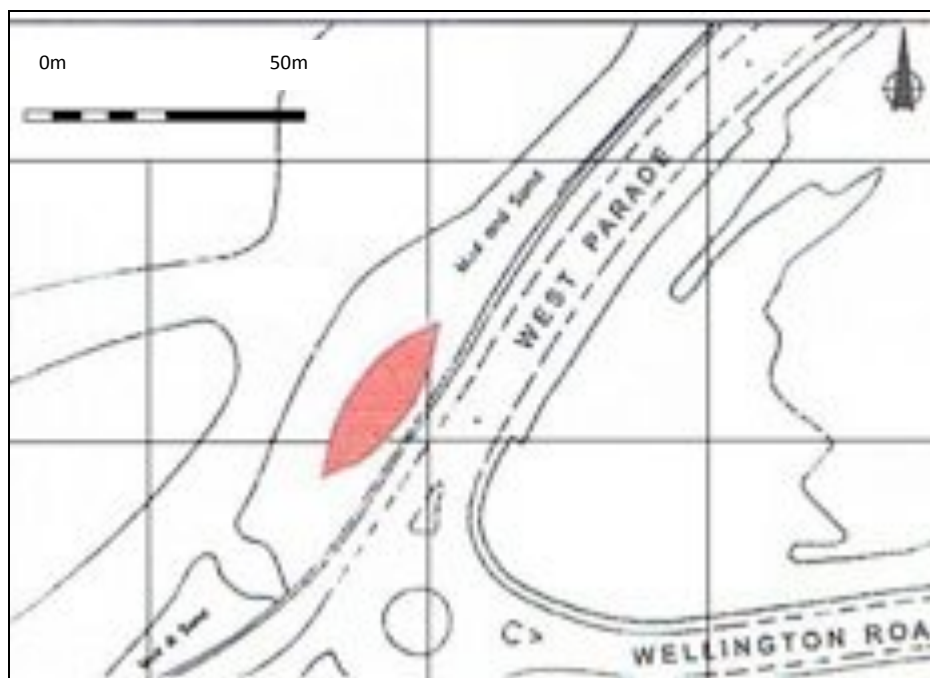
Figure 4. Location of the *City of Ottawa* (after Gifford)

The survey focused on the wreck of the *City of Ottawa* a vessel that rests on the landward side of the banks of the River Clwyd towards the downstream limit of its estuary, grid reference SH 9959 8069 (figure 4). The wreck is located a few metres from the sea wall upon a silty mudflat, exposed at low tide.

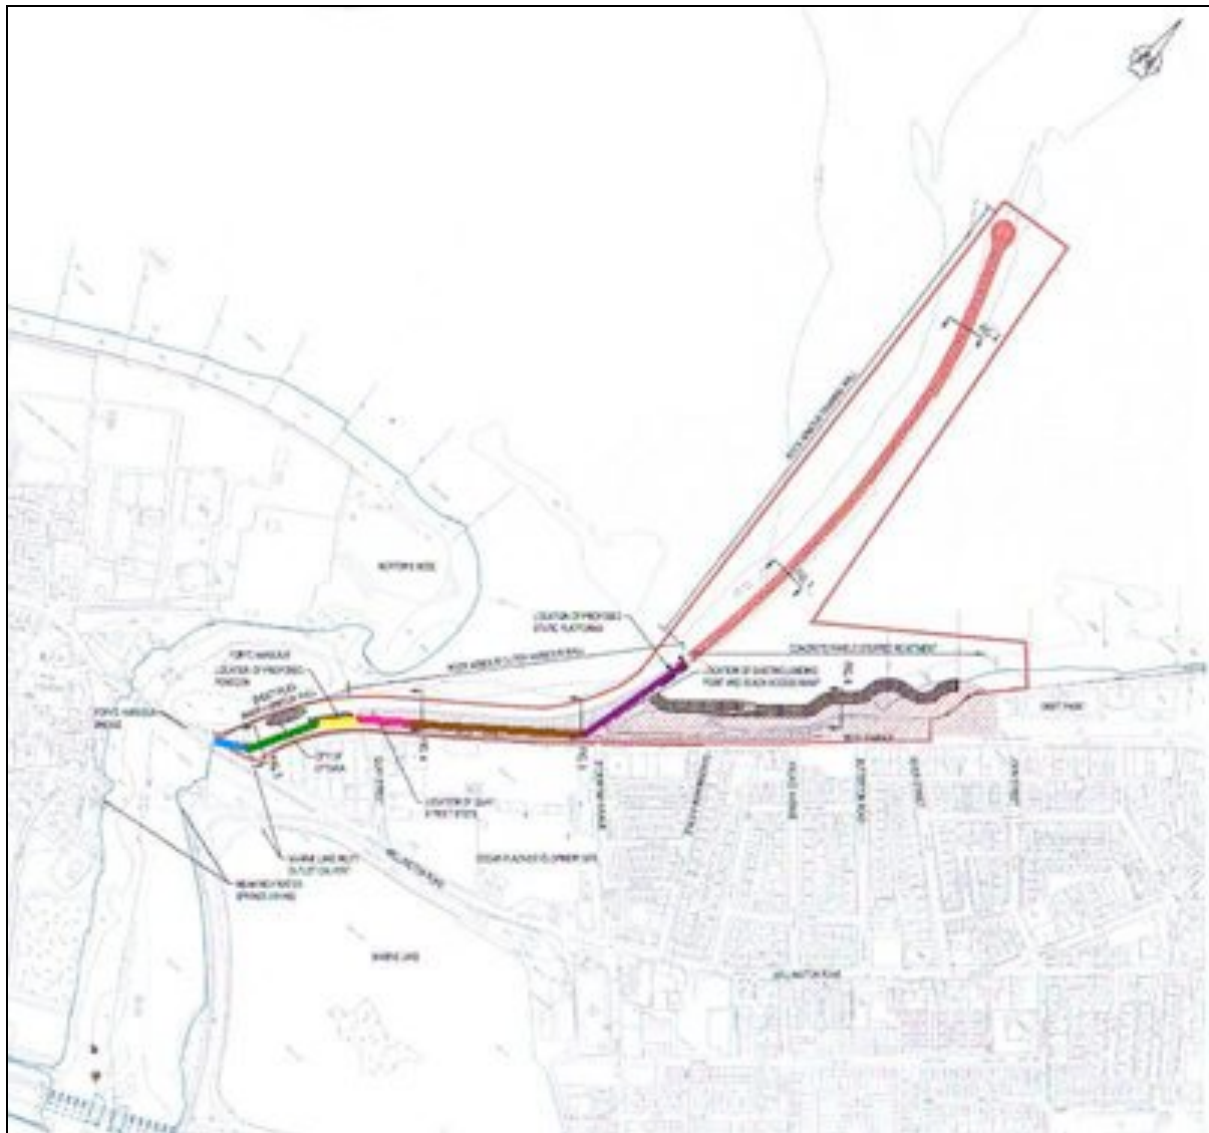
Figure 5. Location of study areas

To assist the provenance of any observation, the study area was divided into sections (figure 5) that accorded with the construction programme. These construction sections can be summarised as:

- Section A; bridge to outfall requiring silt removal and excavation of the piling trench (blue outline)

- Section B; outfall to the end of the silt bar requiring silt removal and excavation of the piling trench whilst monitoring the extant remains of the City of Ottawa (green outline)
- Section C; end of silt to the proposed pontoon requiring excavation of the guidance trench (yellow outline)
- Section D; proposed pontoon to a concrete groyne requiring excavation of the guidance trench (pink outline)
- Section E; concrete groyne to the beginning of the training wall requiring excavation of the guidance trench (brown outline)
- Section F; the training wall requiring excavation of the guidance trench (violet outline)

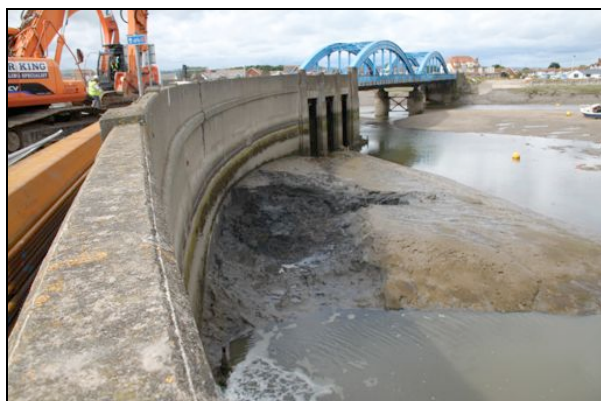
Figure 7. Section A showing excavated silt

The accumulated material was up to 1.00m overlying a hard pebble beach (figure 7) with deposition occurring relatively recently as street furniture and other modern detritus was recovered.

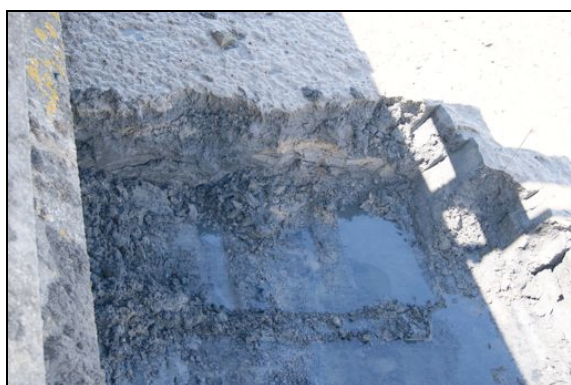
Figure 9. Section B, Overburden above beach

The slurry covered interleaving bands of grey and yellow sand (figure 9), the slurry accumulated since the arrival of the City of Ottawa, adjacent to the study area.

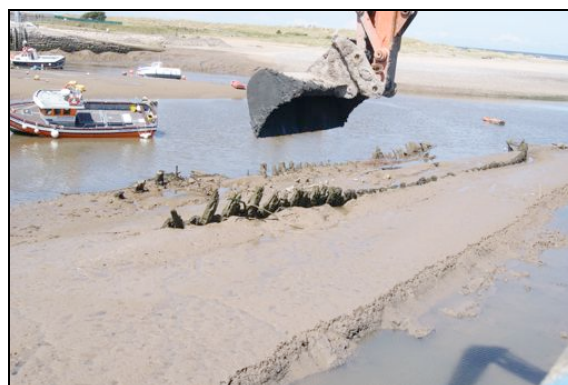
Figure 10. Section B, removing silt near the wreck

The groundworks successfully avoided the extant wreck of the *City of Ottawa* leaving its remains *in situ* (figure 10) although a number of scattered and discarded artefacts attributable to the *City of Ottawa* were recovered. These artefacts are discussed below (section 5.4).

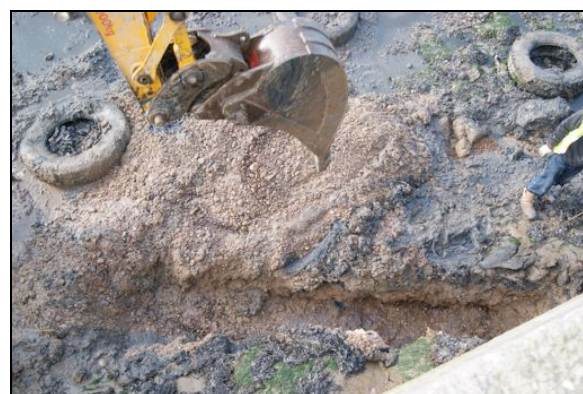
Figure 13. Section D, guide trench with gravel

As with Section C, the guidance trench for the sheet piling was excavated to a depth of approximately 1.50m (red outline, figure 14). The trench rapidly collapsed and was inundated by water. Observations showed a shingle beach that developed into coarse, clean golden sand probably part of an earlier sand bar (figure 13). No cultural activity was encountered although very occasional 19<sup>th</sup> century brick and 20<sup>th</sup> century concrete emerged probably the result of sinking into soft ground.

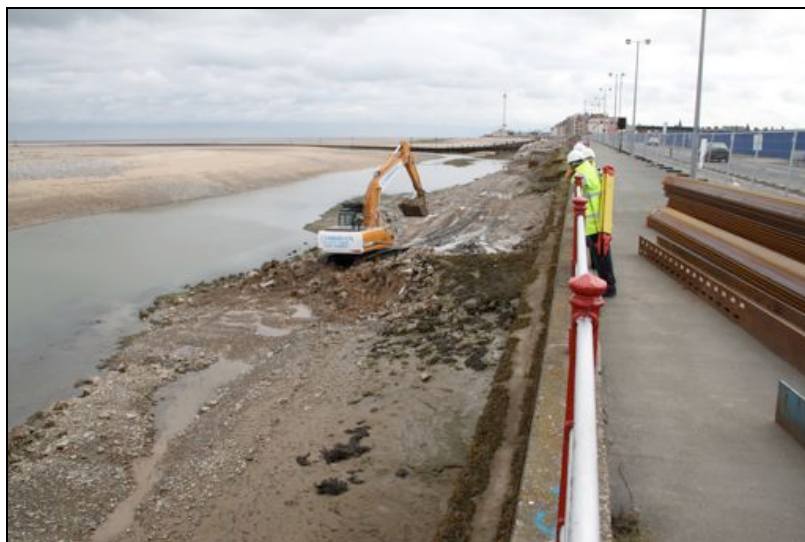
Figure 15. Section E

A minimal watching brief involving the excavation of a guidance trench (figure 15) was required for this area as it was clear from previous examination of the adjacent area that the location was archaeologically sterile.

Observations in this area confirmed the shingle beach encountered in Section D. No buried ancient ground surfaces were present.

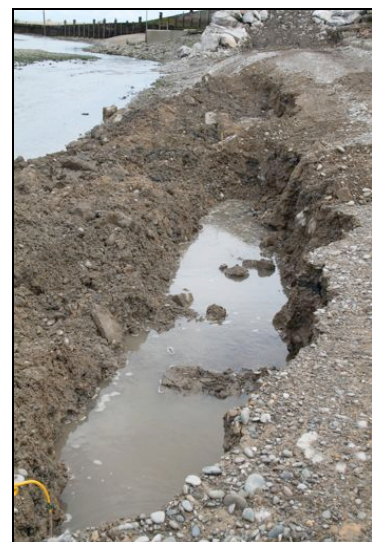
Figure 16. Section F

A minimal watching brief involving the excavation of a guidance trench (figure 16) was required for this area as it was clear from previous examination of the adjacent area that the location was archaeologically sterile.

Observations in this area confirmed the shingle beach encountered in Section D. No buried ancient ground surfaces were present.

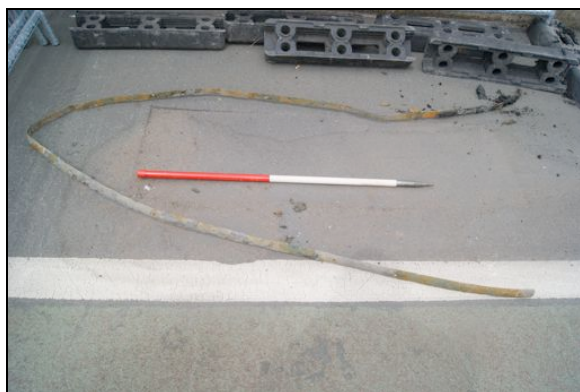
Figure 17. Copper banding (59)

- 59. A copper strip, 4.45m x 0.04m and 5mm in thickness bearing a bevelled profile (figure 17). There existed nail holes at 0.20m intervals. This item appears to be some form of banding possibly attached to the hull, but could be some form of finish to a wooden hand rail

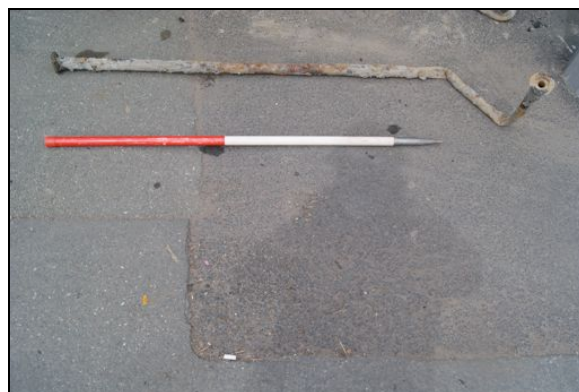
Figure 18. Handrail (62)

- 62. A bent cylindrical rail 1.81m x 35mm in diameter with flat discs 65mm in diameter at each terminal (figure 18). The disc terminals bore four screw holes that probably connected the rail to a mount
