The western half of a block of back-to-backs was uncovered comprising four identical brick units. These buildings were probably constructed between 1810 and 1840 and despite their modest construction appeared to have been sound dwellings until their demolition during the 1950s.

The author of this report Gerry Martin has been commissioned by Mr Mike Dockwray to enact a Programme of Archaeological Watching Brief Action relating to the ground works for an industrial building at land off Middleton Road, Royton, Greater Manchester OL2 5LS (grid reference, SD91555 07434).

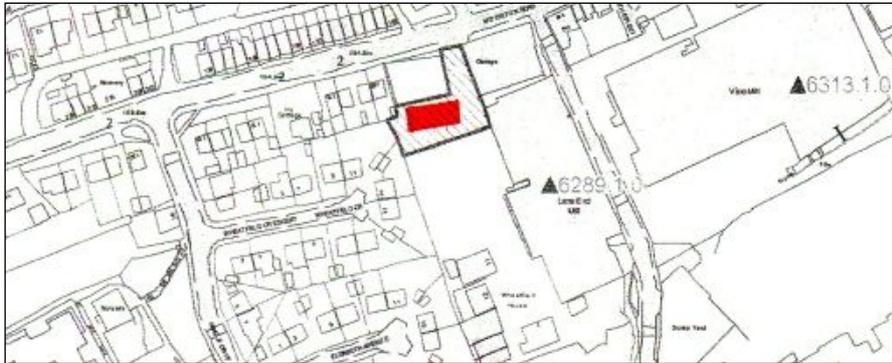
*Figure 2. Location of study area (study building in red)*

The study area (SD 91555 07434) lies adjacent to the one of the weaving sheds that formed part of an early 19<sup>th</sup> Century cotton mill, Lane End Mill (SMR 6289.1.0) and which lay in the shadow of a similar but later, larger cotton mill, Vine Mill (SMR 6313.1.0).

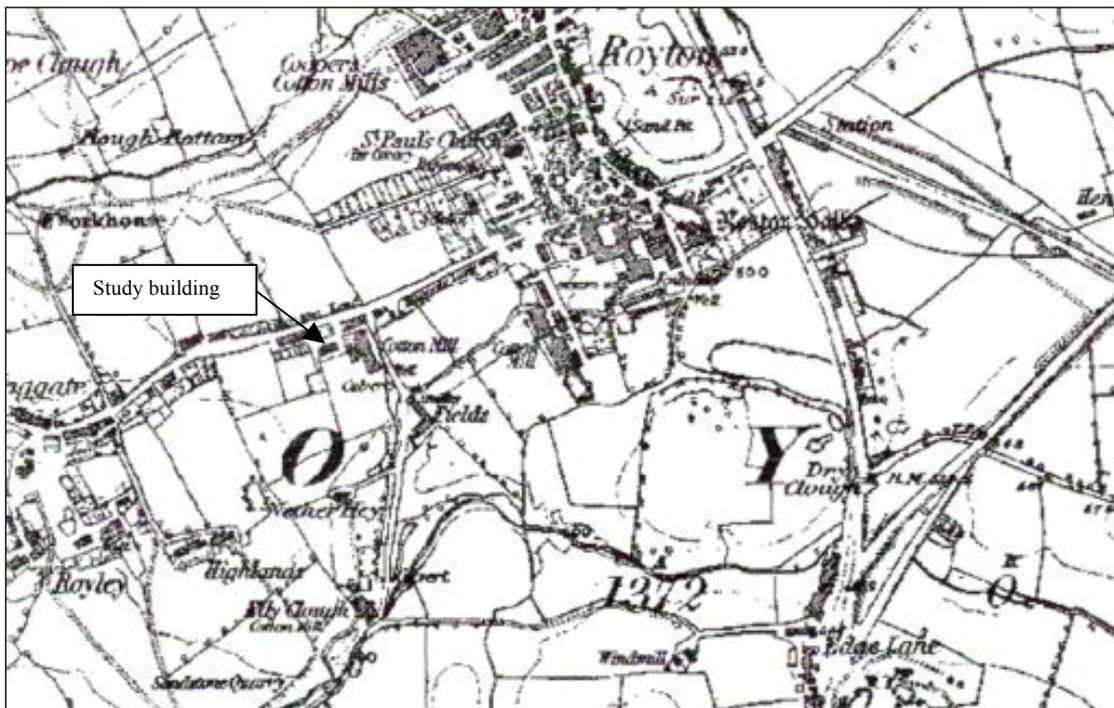
*Figure 3. First Edition Ordnance Survey map 1848*

The 1848 Ordnance Survey map illustrates widely dispersed cotton mills utilising the benefit of a fast running water as a source of mechanical power, but also a number of mills such as Vine Mill that do not appear to be close to a leet or beck. It is likely that mechanical traction was offered by steam at these sites inferring a later date for establishment than those utilising water-courses.

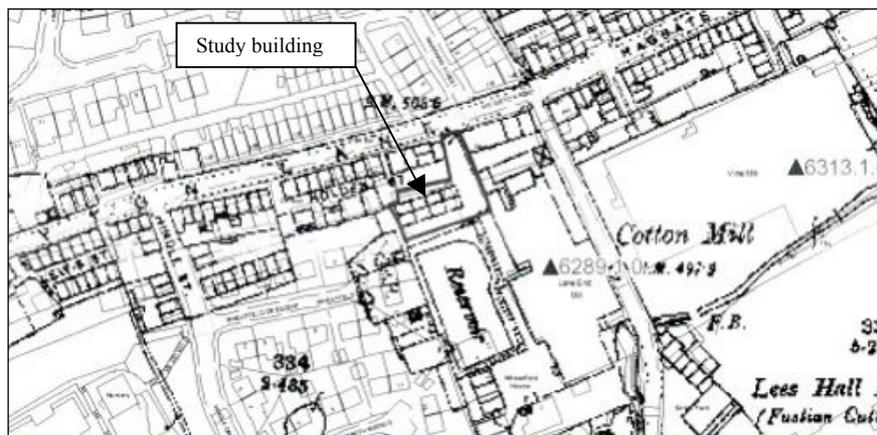
*Figure 4. 1892 Ordnance Survey map*

The 1892 Ordnance Survey map illustrates this activity. Ribbon development is intense along Royton Lane (now Middleton Road) with terraces of houses backing onto each other. The study area as described above encompasses a rectangular tenement, sub-divided into eight units of identical size, detail that cannot be ascertained from the First Edition 1848 map.

The uncovering of the ground plan revealed the western four units of a tenement illustrated on the 1892 Ordnance Survey map. The southern frontage of the tenement was fully exposed but the northern frontage was approximately 1.00m outside of the building footprint and was not uncovered.

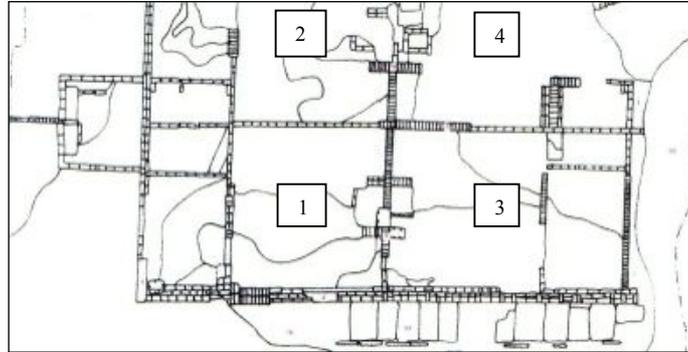
*Figure 5. Lay-out of dwellings*

Each unit yielded three rectangular rooms, a large parlour, a small kitchen or store and an adjoining larder or coal store that would have been below a flight of stairs leading to an upper storey. Every parlour possessed a brick hearth that probably served as a range, possibly a later adaptation.

The nomenclature used describes each unit as a “Dwelling” e.g. the southwest unit being Dwelling 1, northwest Dwelling 2, southeast Dwelling 3 and northeast Dwelling 4, with the parlour always being “Room 1”, the possible kitchen as “Room 2” and the below stairs room as “Room 3”.

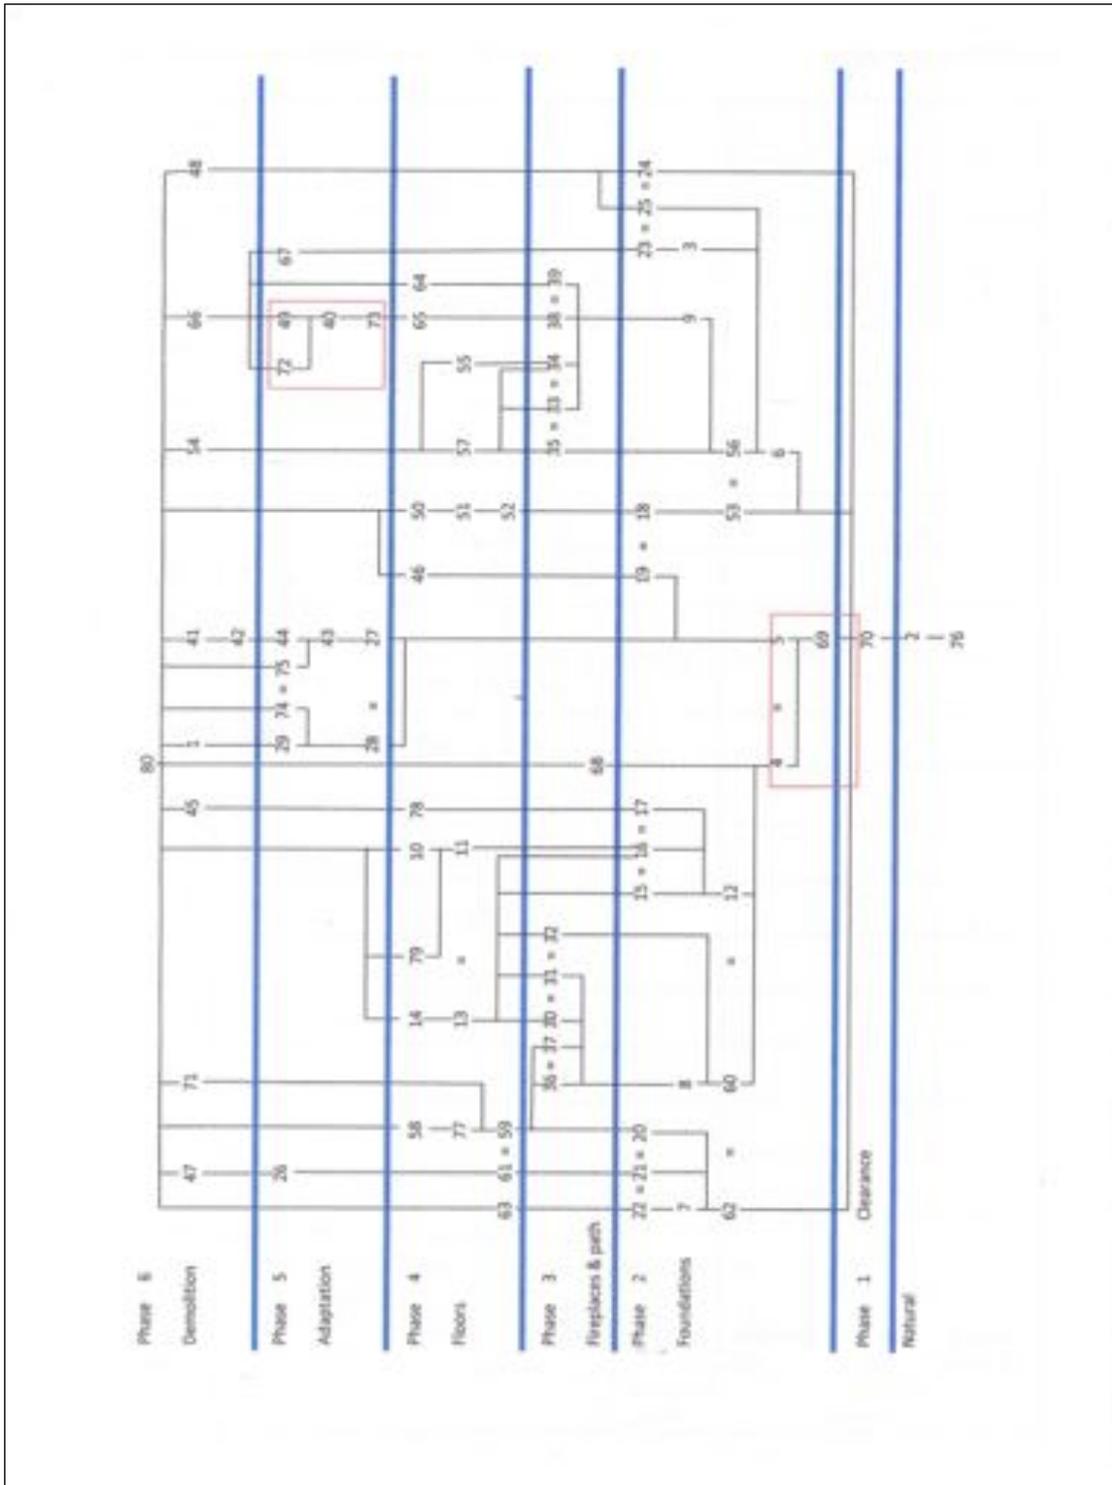
Figure 6. Site matrix

The building possessed six phases of activity of which phases one to four were wholly associated with the buildings construction. These are summarised as:

- Phase 1 Clearance of the site, truncation level 70
- Phase 2 Insertion of foundations 69 for the buildings shell
- Phase 3 Construction of fireplaces and the buildings brick super-structure
- Phase 4 Laying of the flagstone floor
- Phase 5 Adaptation during the lifetime of the building e.g. water pipes
- Phase 6 Demolition during the 1950s

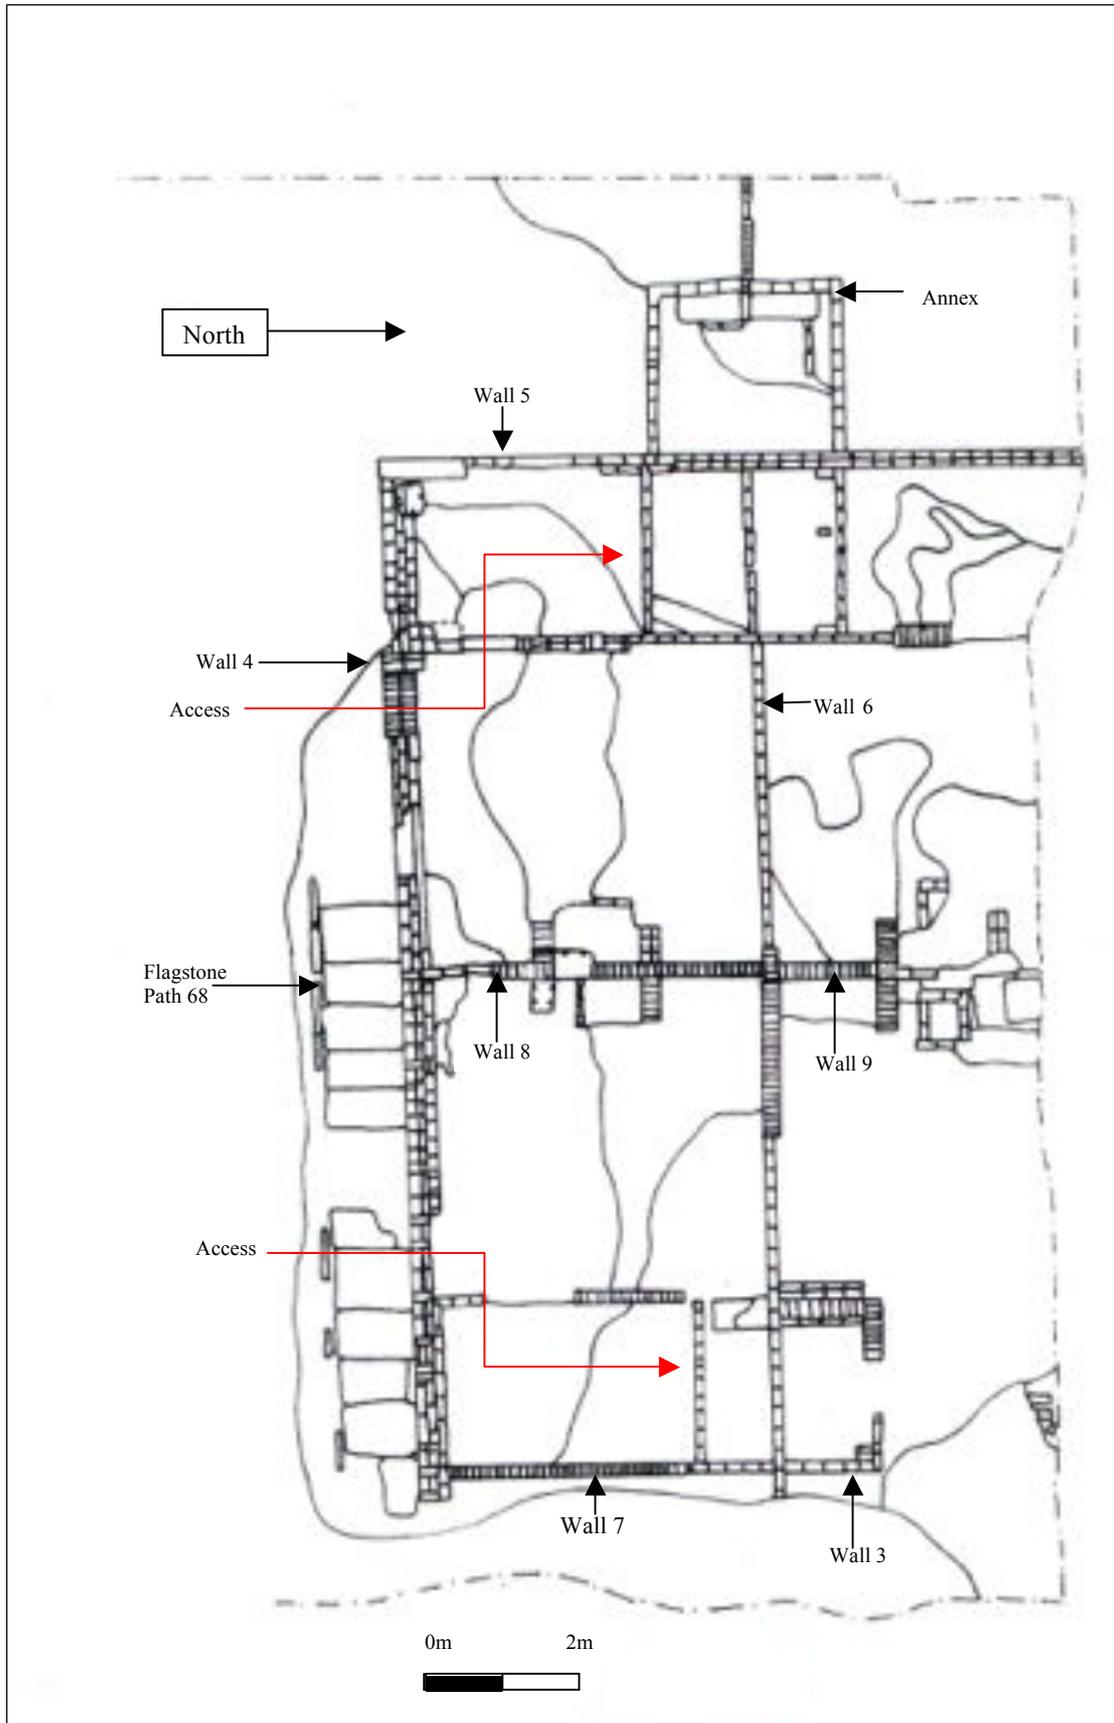
*Figure 7. Site plan with principal features*

Dwelling 1 was separated from Dwelling 3 by a north-south party brick wall 8 that continued northwards as wall 9 forming a party wall between Dwelling 2 and Dwelling 4.

Dwelling 3 was separated from unexcavated Dwelling 5 by a north-south party brick wall 7 that continued northwards as wall 3 forming a party wall between Dwelling 4 and unexcavated Dwelling 6.

Dwelling 1 was sub-divided into three spatial units with the installation of a north-south aligned brick wall 15 that continued northwards with brick wall 16, Room 2, where it met central party wall 6. Between wall 16 and wall 5, an east-west brick wall 17 was inserted to form a small cell, Room 3.

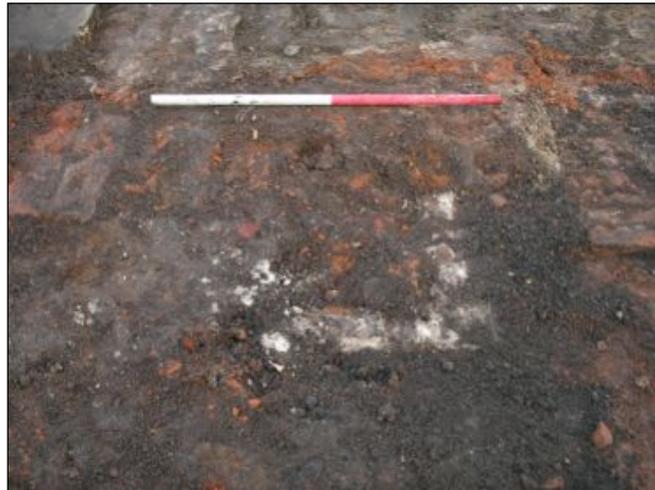
*Figure 8. Fireplace in Dwelling 2, Room 1*

The fireplace in Dwelling 2, Room 1 consisted of two parallel east-west aligned brick walls 33 and 34. A brick right-angle 35 was situated within the space between these two walls, possibly representing an unexcavated ash box comparable to brick feature 40 (phase 5). However, as brickwork 35 was apparently sealed by unexcavated layer 57 (phase 4), this physical relationship suggests that brickwork 35 belonged to phase 3.

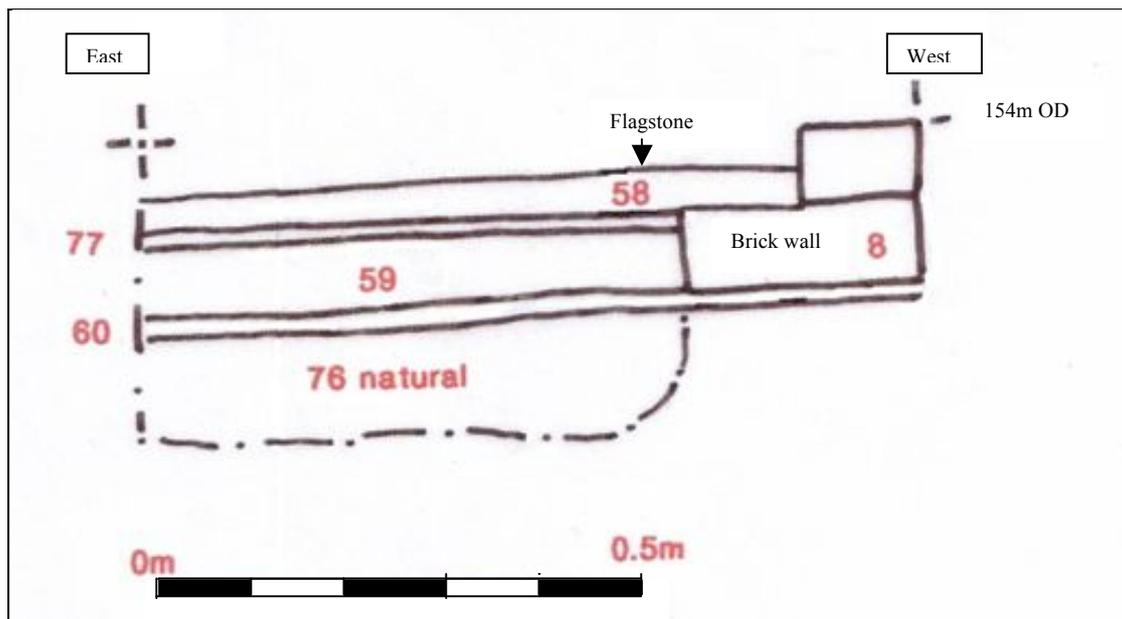
Figure 9. Section through floor deposits

In Dwelling 3, Room 1 butting walls 36 and 37 and wall 21 respectively, (both phase 2) were yellow clay spreads 59 and 61, respectively. Layer 61 was overlain by stone step 26 (phase 5), whilst layer 59 was beneath a light grey silty sand 77 grouting a *Yorkshire greys* flag surface 58 sealed by demolition horizon 80 (phase 6).

The floor to the parlour from the outset would have been stone, formed from *Yorkshire Greys*. Beneath these flagstones was a layer of grouting sand and a membrane of impermeable yellow clay (usually two layers). In Dwelling 1, the original grouting sand may have been replaced by clinker as a bedding material. Although rudimentary, an attempt has been made to seal the floor from rising damp yet allow excess water to be dispersed.

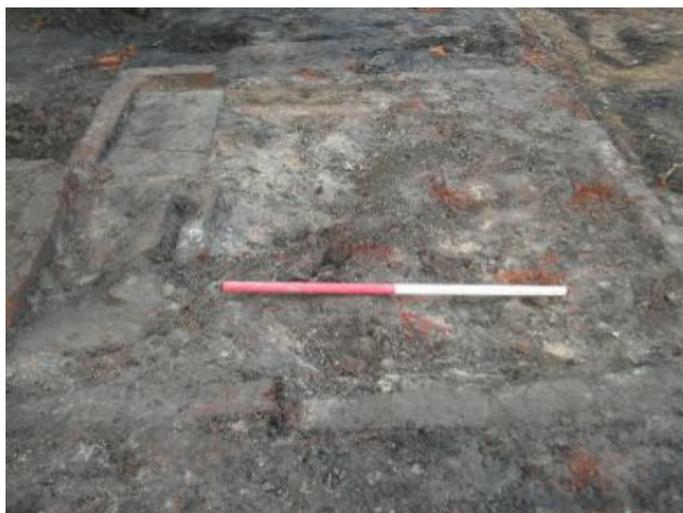
*Figure 10. Annex beside Dwelling 1*

Butting the western end of the building wall 5 (phase 2) was a brick annex formed by L-shaped brick walls 28 (adjacent to Dwelling 1) and 27 (adjacent to Dwelling 2). The two contexts comprised a single skin of red brick set on bed in a stretcher pattern,

Water was collected presumably from a communal well and heated on the range. A small annex attached to Dwellings 1 and 2 may have served as a laundry. Flagstones 74 and 75 may have supported coppers, as ash and charcoal was prevalent nearby.

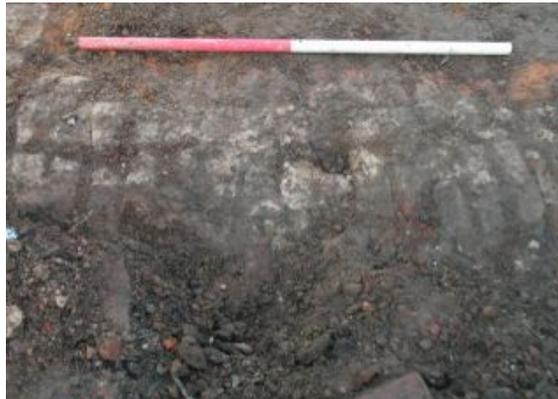
*Figure 11. Threshold into Dwelling 1*

Dwelling 1 articulates the typical organisation of space within one of these dwellings. Access was through a threshold (0.80m in width) denoted by a double set of bricks set head-to-head and adjacent to Room 2 where a doorway (0.70m in width) existed between walls 15 and 16.
