Regarding the impact of a planning application (3/07/0791) for the conversion of a ruined structure (the mill) and a former pigsty into two holiday cottages at Ravenbridge Mill, Renwick, Cumbria County Council's Historic Environment Service (CCCHES) was consulted by Eden District Council.

The scheme affects an area of archaeological significance, recorded on the County Historic Environment Record as Huddlesceugh Corn Mill (CCC HER 10573). Further information concerning the location, survival and significance of the known archaeological remains on the site (including the two structures affected by the proposed development), as well as the potential for unknown archaeological remains was required.

A Design Brief set out the requirements for an archaeological desk-based assessment and a level 1 survey of the ruined structure and pigsty. Dependent upon the results of the desk-based assessment, an archaeological watching brief may be required as a future phase of archaeological work to record any remains disturbed by the development. The scope of the watching brief will be driven by the results of the desk-based assessment and if necessary will require the production of a separate Des

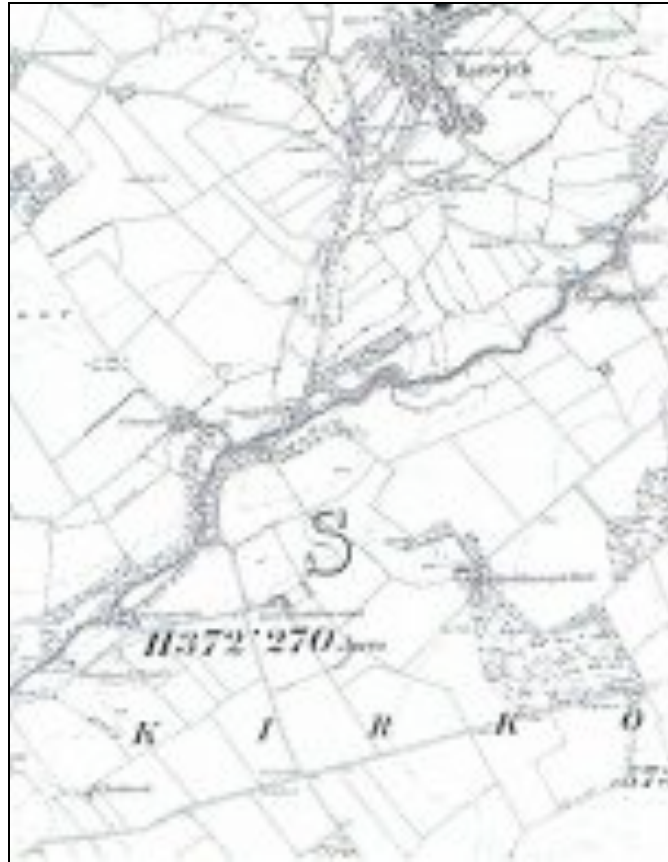
*Figure 7. First Edition Ordnance Survey map 1867*

The first edition 1867 Ordnance Survey map illustrates Ravenbridge Mill (the study building) and appears to show a short stretch of a mill race that coincides with a slight kink in Raven Beck.

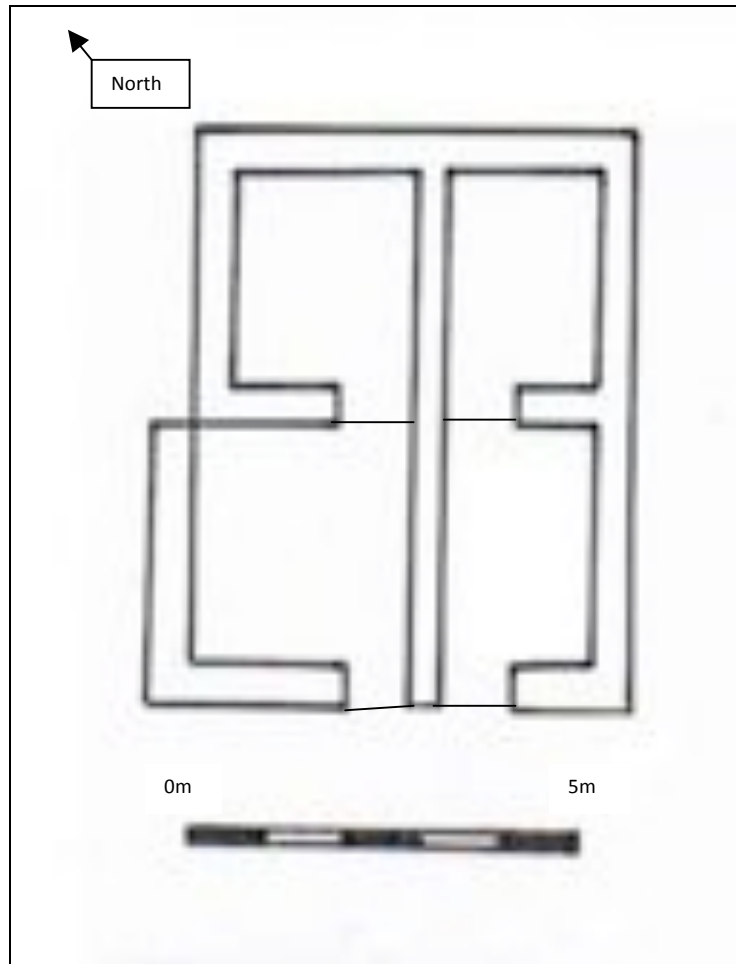
*Figure 8. Plan of the pigsty*

The pigsty measured 5.55m x 3.80m in plan (figure 8), possessed a facade that was 1.30m in height, 0.50m in width with a further 1.10m in height to the apex of the roof and consisted of a central red

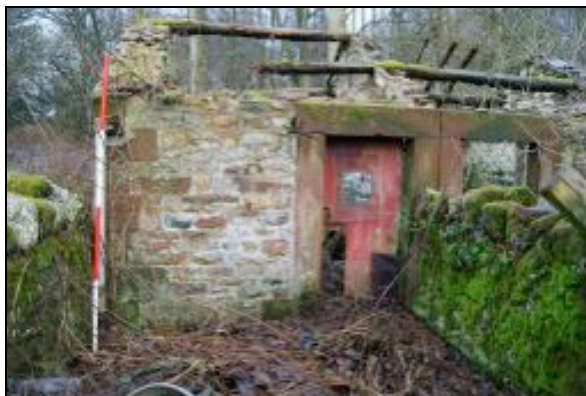
*Figure 9. Facade of northern unit in the pigsty*

dressed sandstone door jamb with a 0.90m wide entrance formed from stones 0.25m in width (figure 9). A single door remained, built in timber tongue and groove. The structure was built from coursed, rough hewn dressed sandstone blocks measuring 0.20m x 0.15m x 0.12m (figure 11). No roof was present but it probably comprised red sandstone shingles. The guttering was missing.

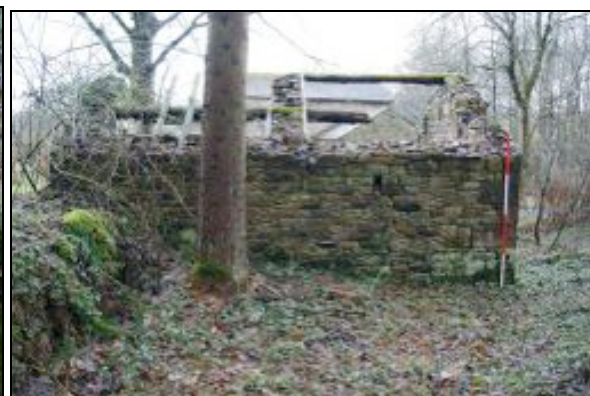
*Figure 10. South elevation of pigsty with vents*

Each unit within the pigsty possessed single ventilation slits (figure 10) at the rear measuring 0.25m in height and 0.10m in width.

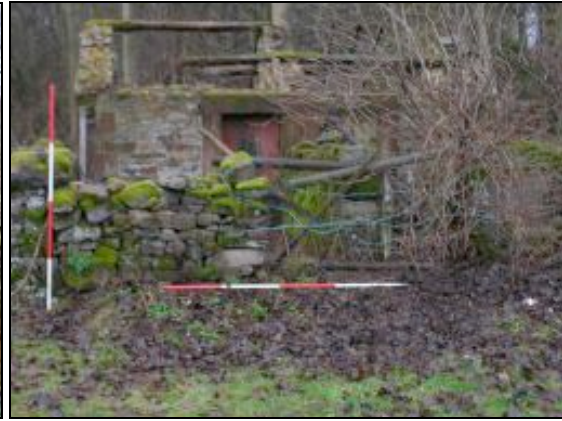
*Figure 12. Western elevation showing pens*

Added later, were two stone pens measuring 6.05m x 3.80m (figure 12) comprising dry-stone walls measuring 0.50m in width, standing to 1.20m in height complemented with a coping of angled, flat stones. The southern wall had been partly repaired with breeze blocks. The pens were divided into two units with a central double entrance and were filled with rubbish.

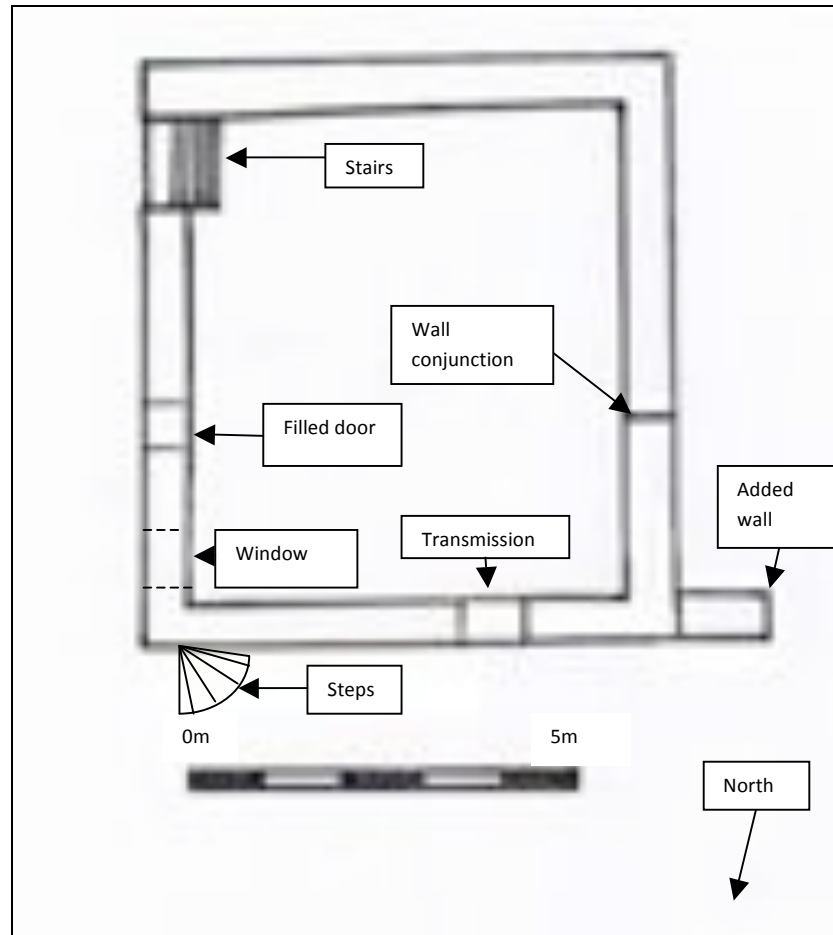
Figure 13. Plan of the ruined mill

The ruined mill (NY 60092 42971) consisted of a rectangular plan building measuring 6.58m x 7.28m with an internal area measuring 5.58m x 6.28m (figure 13). Considerable dumping of debris occurred on the northern side of the mill within the former mill race (figure 15).

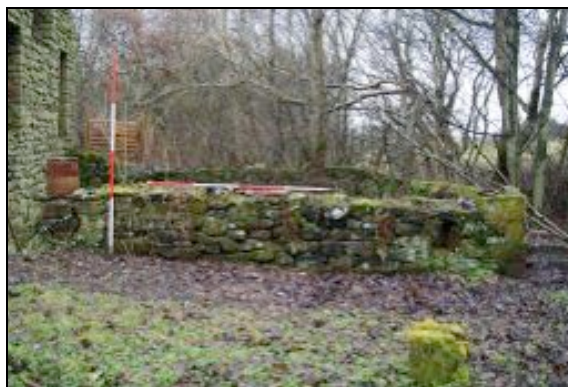
Figure 14. Eastern elevation of ruined mill

The subject building possessed a superstructure of rough hewn stone blocks circa 0.30m x 0.40m in size, smaller towards the corner at 0.20m x 0.30m bonded by a buff sandy clay mortar forming walls 0.50m in thickness (figure 14).

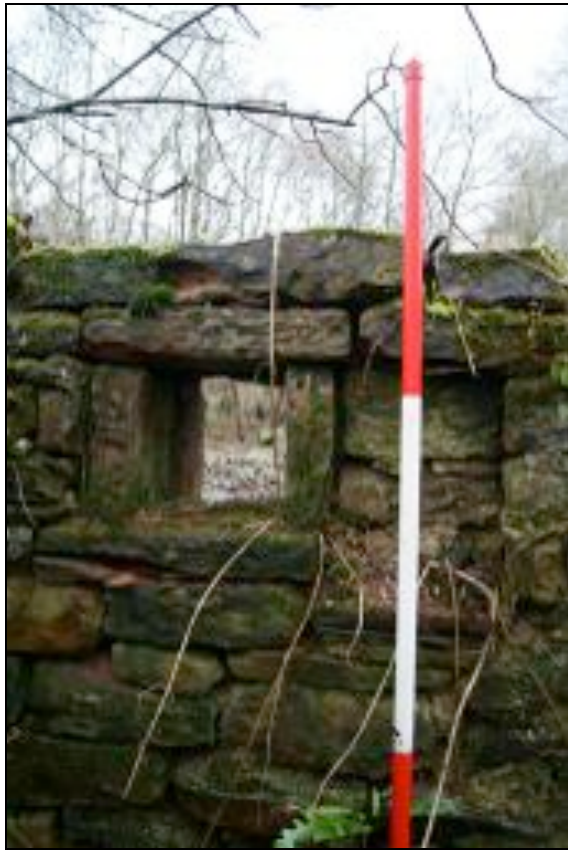
Figure 16. Window in eastern elevation

- A window on the eastern elevation, 0.30m from the north-eastern corner, 1.10m off the ground measuring 0.80m in width (figure 16)
- A blocked window or door on the eastern elevation, 1.80m from the north-eastern corner measuring 0.80m in width (figure 17)
- A blocked door on the northern elevation, 1.30m from the north-western corner measuring 0.80m in width that may have maintained the transmission from the wheel to the grinding stones (figure 18)
- The conjunction of two walls, 2.20m from the north-western corner that suggested two phases of construction (figure 20)

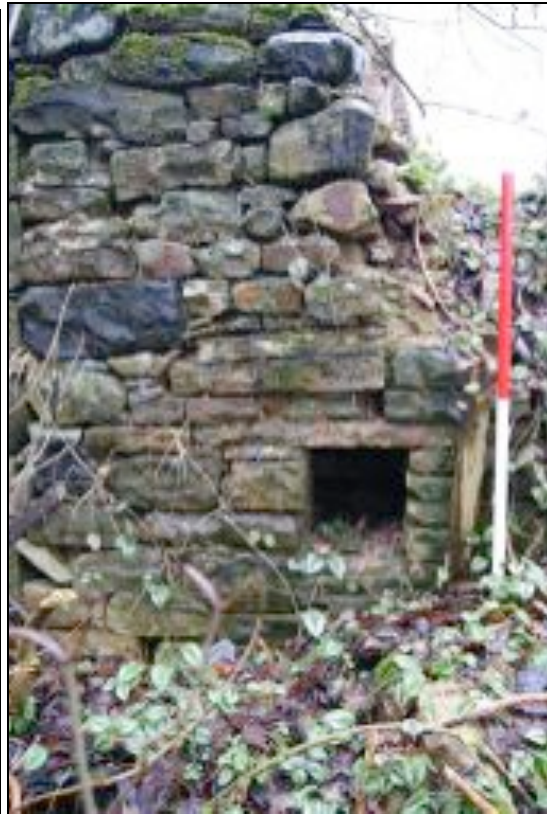
Figure 19. Sluice in additional north wall

A 1.30m length of mill wall appears to have been added that extended westwards from the north-western corner of the Mill. This wall possessed a square sluice (figure 19) within a cruder rough hewn rubble wall (figure 23).

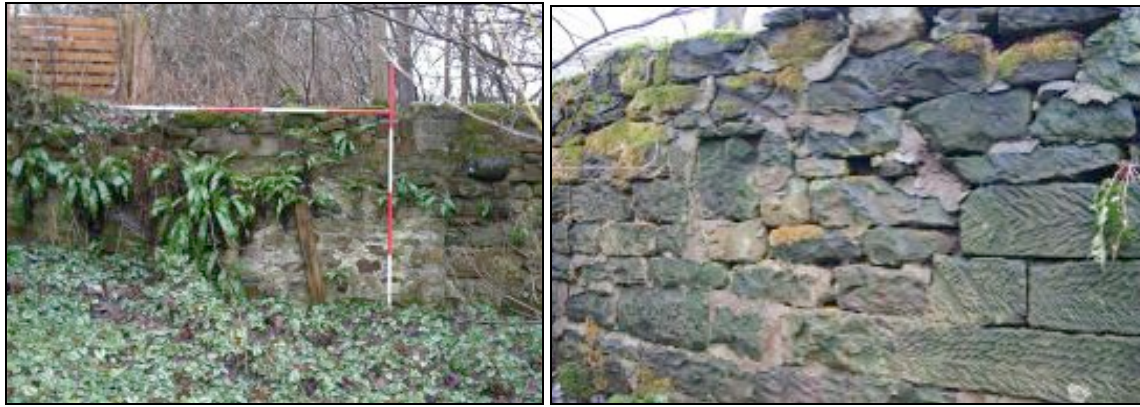
The exterior of the northern elevation, 0.80m from the north-western corner, illustrated an arced scar (figure 21) that represented the waterwheel brushing the side of the Mill. The scar measured 1.20m in radius suggesting that the waterwheel measured 2.40m in diameter.

Figure 20. Conjunction of two western walls

Figure 21. Wheel scar on north elevation

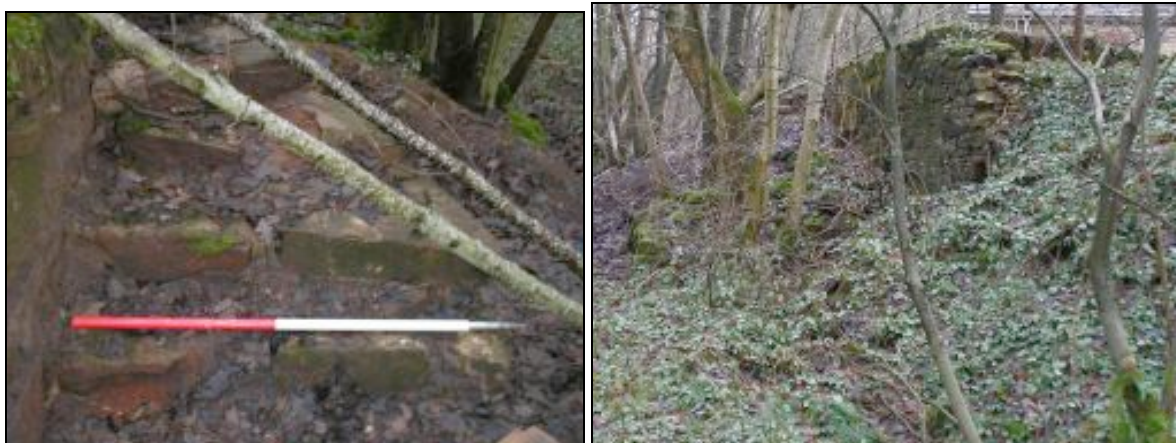
A spiral set of five stone steps (figure 22) 0.70m in height and 1.20m in width was added 1.40m westwards from the north-eastern corner probably after the mill had gone out of use as it was built above the partly filled mill race.

Figure 22. Spiral set of steps

Figure 23. Western extension of the ruined mill

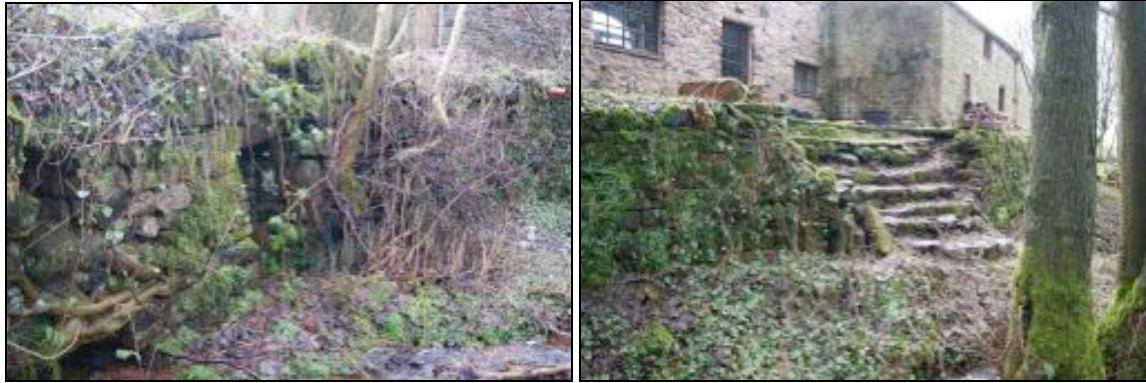
- At the eastern end of the mill race, NY 60123 42985 a small beck (Kiln Beck) has breached through just to the east of a stone revetment. Two metres west of the breach were two stone sluices 1.00m in height and 0.80m in width that were no longer in use (figure 24)
- Opposite the west wing of the house, NY 60097 42965 a flight of seven steps assembled as a fan measuring 3.00m in width and 1.50m in height within a breach in the mill wall (figure 25)

*Figure 24. Sluices at the eastern end of the mill*    *Figure 25. Steps leading up to the mill*

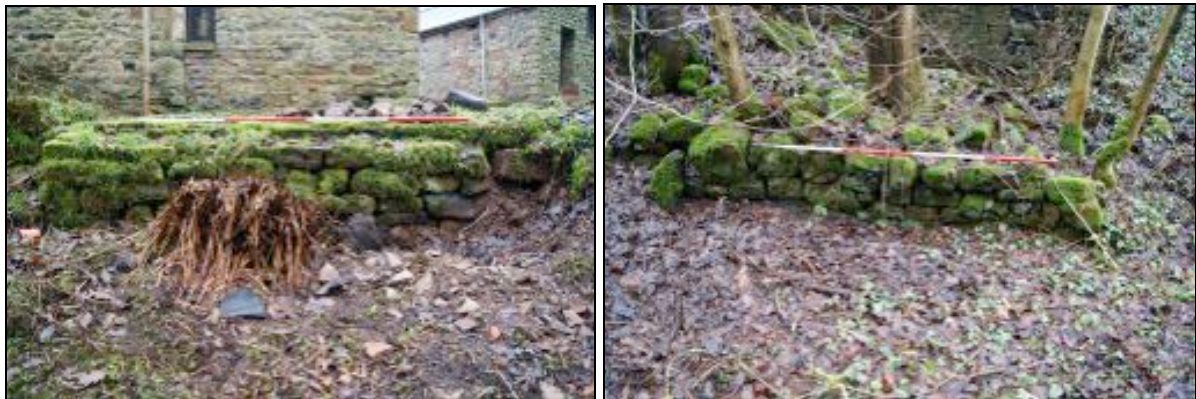
- Two metres east of the north-eastern corner of the ruined mill, NY 60074 42970 was a stone plinth or platform (figure 26)
- A three metre stretch of loose wall, NY 60071 42959 standing 0.35m in height and lying parallel to the Mill, 2.80m apart. The leet was filled with debris up to the top of the wall where the circular steps existed (figure 27).
- Beyond the Mill, the leet continued to NY 60063 42944 as a single course of stones forming the north side of the channel (figures 28 and 29). The leet was infilled and overgrown.

*Figure 26. Stone plinth*

*Figure 27. Leet in front of the ruined mill*

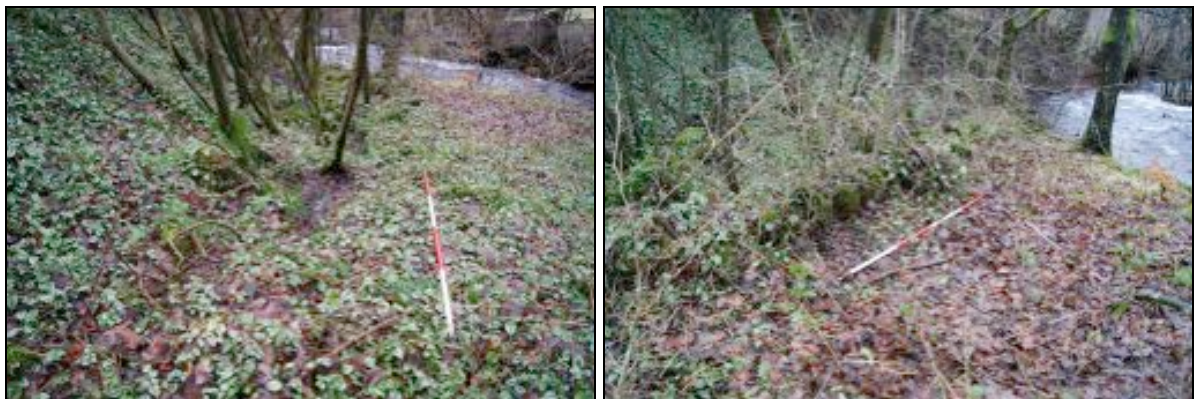
*Figure 28. The overgrown leet looking westwards*    *Figure 29. Single stone course of the leet*

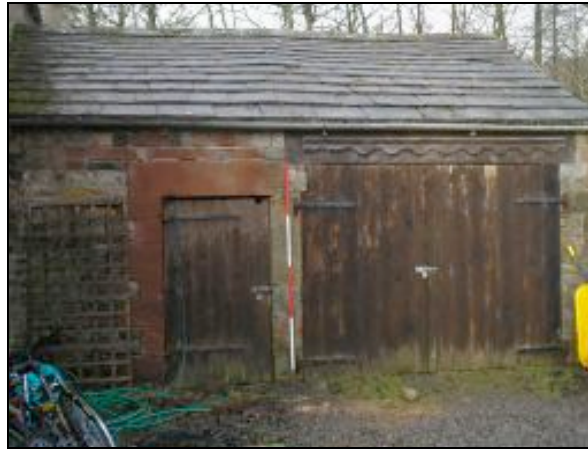
*Figure 30. Outbuilding used as a garage*

A modern stone-built garage had been added to the east wing of Raven Bridge Mill measuring 6.40m x 5.20m and standing to a height of 4.20m that includes 1.50m for the roof of the building.
